# Inspection Report

Exemple 20/INS/002

**10710 S.W. 211 Street  
 MIAMI, FL 33189**

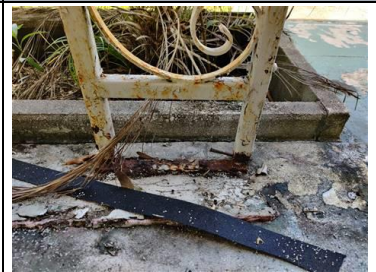
Type	Picture
Porch / Ext. Entry	Porch need to be repainted and steel colons need to be replaced.	RR

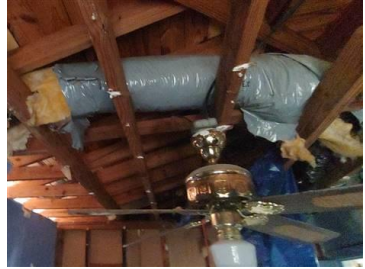
Type	Picture
Ceiling Structure	Ceiling structure needs to be fully restored.	RR

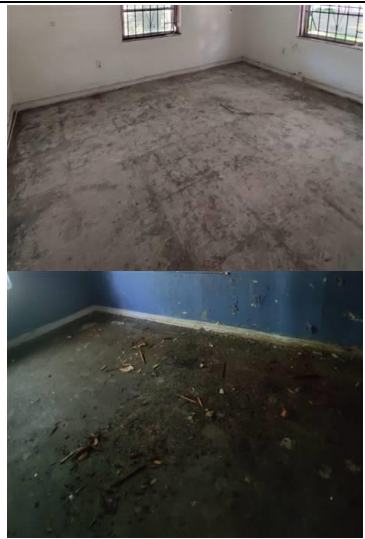
Floor Structure	All floor structure was damaged by the time of inspection and need to be fully restored.	RR

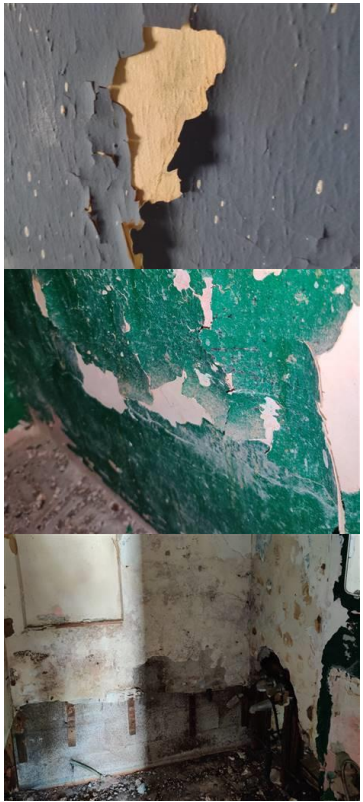
Type	Picture
Wall Structure	Painting and wall structure need to be fully restored.	RR

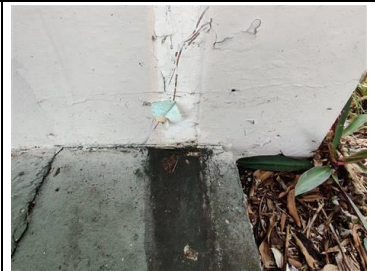
Type	Picture
Gutters	Some gutters were missing by the time of the inspection.	RR

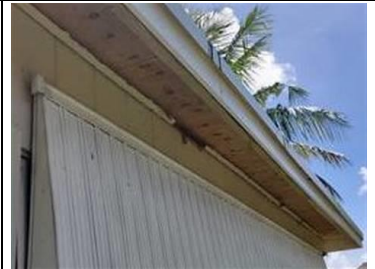
Soffits and Screen - 400	Some soffits are missing and need to be installed.	RR

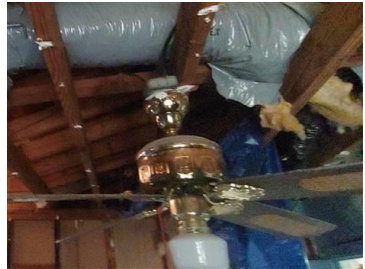
Type	Picture
Celling Fans	Ceiling fans not working and need to be replaced.	RR

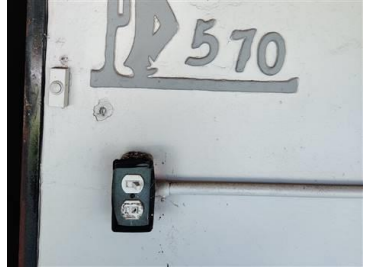
Exterior Outlets	Exterior outlets and switches not working by the type of inspection.	RR

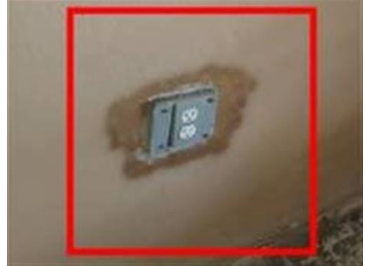
Interior Outlets - Outlets / Switches	Wall outlet is damaged (overheating).	RR

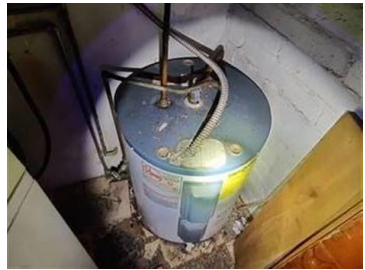
Type	Picture
Water Heater Disconnect	Water heater is failing and need to be replaced.	RR

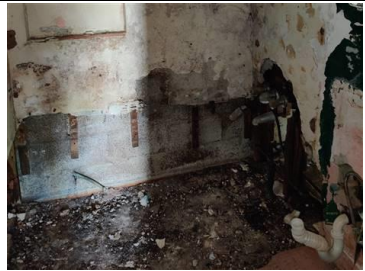
Type	Picture
Bath Sink	Bath sink missing.	RR

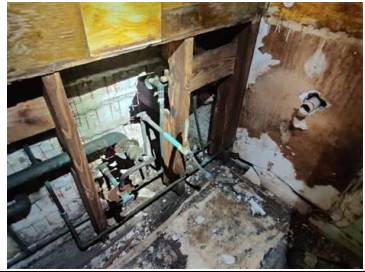
Drain/Waste/Vent Piping	We noted cast iron sanitary piping under the home, visible in the crawl space. The piping has an original life expectancy of 50 years. Based on this, we recommend the buyer budget to replace the piping.	RR

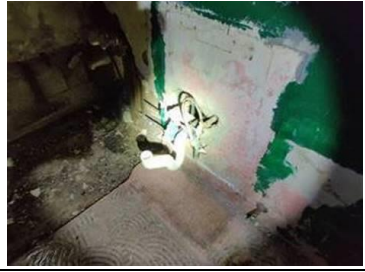
Kitchen Sink	Kitchen sink missing.	RR

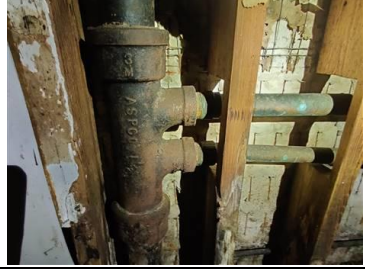
Visible Distribution Piping	Distribution piping need to be fully restored.	RR

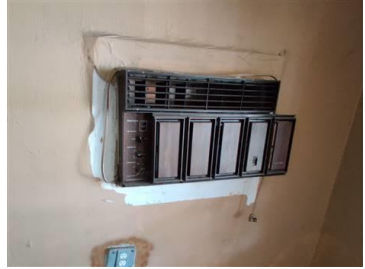
Type	Picture
Air Handler Unit(s)	Air handler unit outdated and need to be replaced.	RR

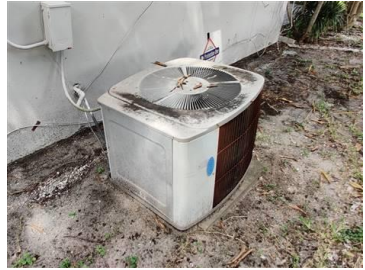
Condensing Unit(s)	Condensing unit not working by the time of inspection and need to be fixed by a specialist.	RR

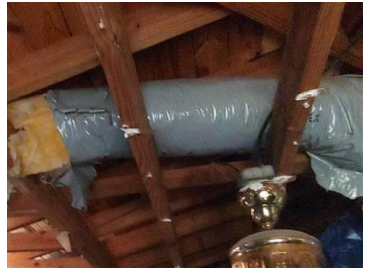
Ductwork	Ductwork damaged and needed to be replaced.	RR

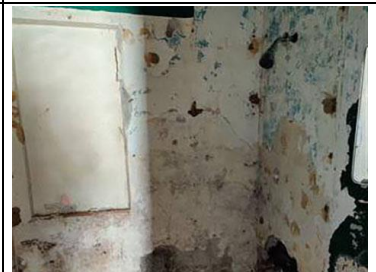
Type	Picture
Baseboard Material - Deteriorated Baseboard	Baseboard is deteriorated and needs to be repaired or replaced. Some baseboard is missing.	RR	
Bathroom / Walls	Bathroom walls are damaged and deteriorated.	RR

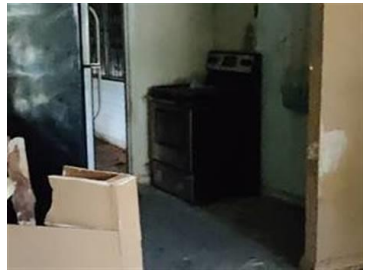
Type	Picture
Kitchen - Walls	Kitchen Walls needs to be partially replaced.	RR

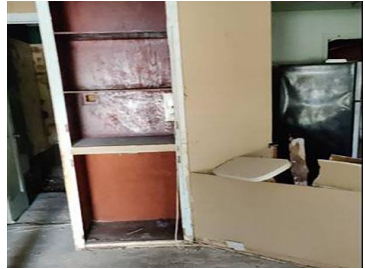
Living Room - Closet Door(s)	Living Room Closet Door is missing.	RR

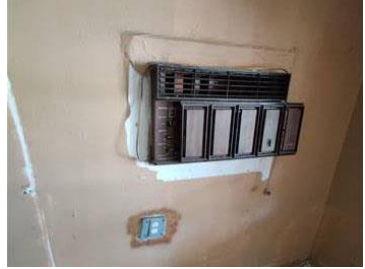
Living Room - Walls	Living room walls show signs of moisture.	RR

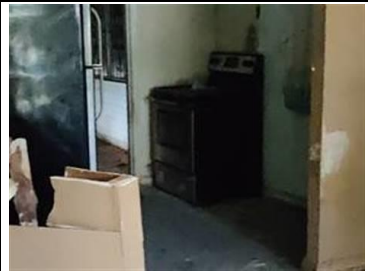
Type	Picture
Oven	Oven outdated and not properly working, need to be replaced.	RR

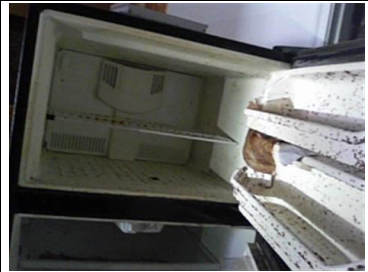
Refrigerator	Refrigerator infected by bugs need to be replaced for health reasons.	RR
