# Inspection Report

Exemple 20/INS/002

**10710 S.W. 211 Street  
 MIAMI, FL 33189**

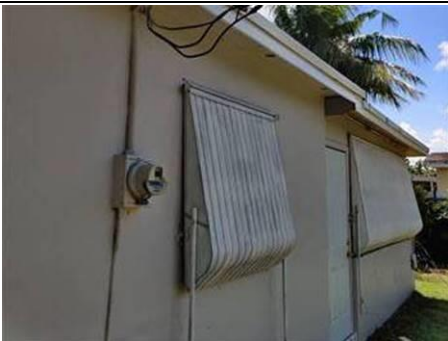
UNRATED SHUTTERS

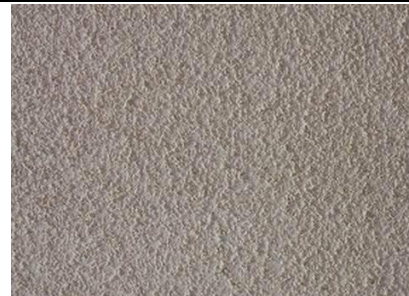
Location	Identification + Description	Photo
1st Floor - Sunroom	<u>Material ID:</u> ACBM-002-P002 <u>Description:</u> Projected coatings <u>Type:</u> RACM
